Montecito Sanitary District & Montecito Water
District
Enhanced Recycled Water Feasibility Analysis

Technical Memorandum 3 CONDITION ASSESSMENT

FINAL | April 2022

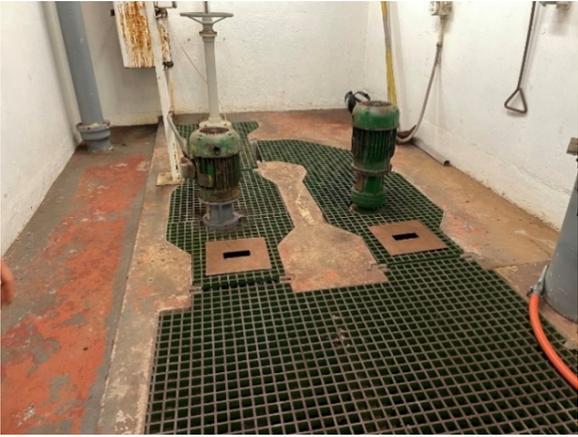
Photo 3.1 Influent Wet Well Overview

- **Influent Wet Well, Gate, and Channels:** The influent wet well, gate, and channels were evaluated to be in overall poor condition. The influent gate is very corroded, but staff noted it is still serviceable (Photo 3.2). Staff exercises the main influent gate regularly and they feel it is in good condition mechanically. The channels have concrete surface loss with exposed aggregate. There is concrete spalling from the side of the frame and severe corrosion of the grating supports including spalled concrete at the grating support locations (Photos 3.3 and 3.4). The stop plates used to take channels in and out of service for maintenance are operational but very corroded (Photo 3.5). There is a lot of corrosion in the channels, gates, and grating framing that supports the grating. Rehabilitation or replacement of concrete may be warranted for safety and should be carefully monitored (Photo 3.5). Staff switches channels each week to clean and de-grit the channel. Corrosion is severe at equipment conduits (grinders, Photo 3.6), and the floor coating is in poor condition.

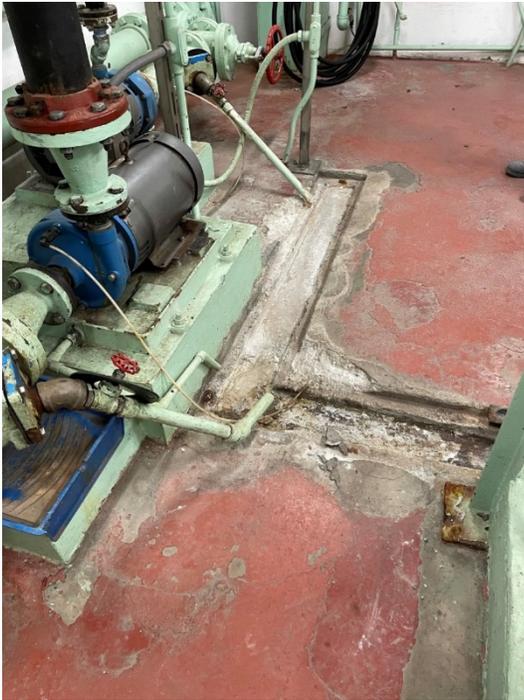
Photo 3.9 IPS Pump Room (Intermediate Level)

- IPS (intermediate level): The intermediate level of the IPS room interior was evaluated to be in overall poor condition. It shows signs of corrosion and age. Anchorage for some pumps appear to be insufficient (Photo 3.10). Mechanical piping shows some corrosion and signs of wear. The gas monitor did not appear to be functional during the site visit, so a portable gas monitor was used. The gas monitor has since been replaced and is functioning properly. There is a drainage channel at the floor slab that is corroded with spalled concrete (Photo 3.9). The floor coating is delaminating, and the equipment hatch is damaged at the floor (hinge).

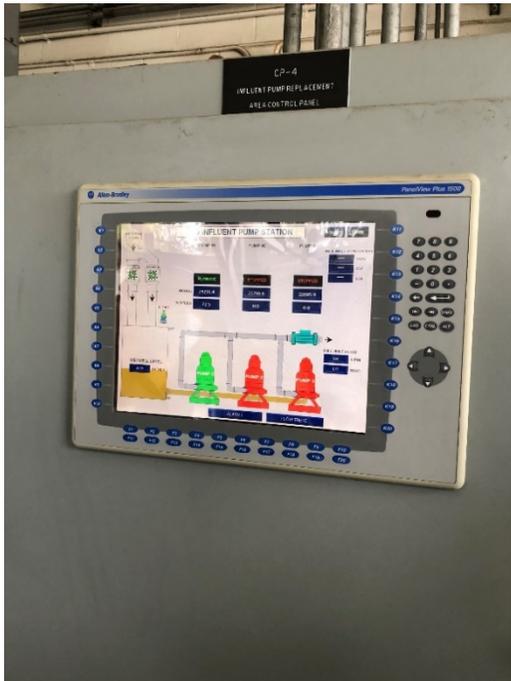
Photo 3.11 IPS Control Panel

- IPS Control Panel: The IPS control panel was evaluated to be in overall good condition. Although the IPS control panel is more than 10 years old, it is in good condition with normal wear.

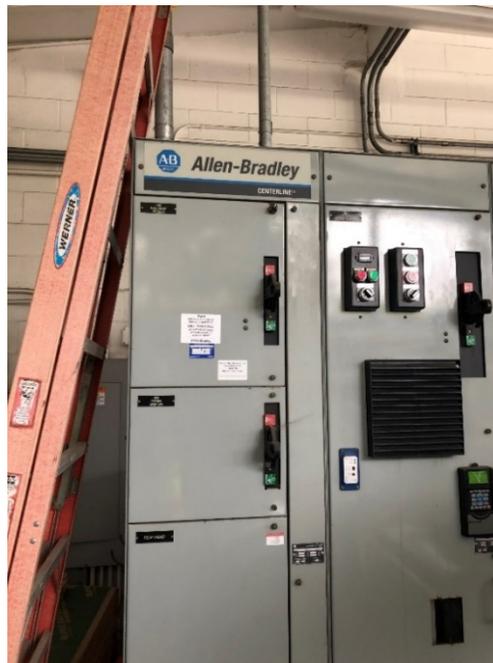
Photo 3.12 IPS VFDs

- IPS Variable Frequency Drives (VFDs): The IPS VFDs were evaluated to be in overall good condition with moderate rusting. They were replaced in the early 2006, but currently past their EUL. They are performing well, however, experiencing rust and corrosion inside and out. This could be due to moisture and potentially hydrogen sulfide (H₂S).

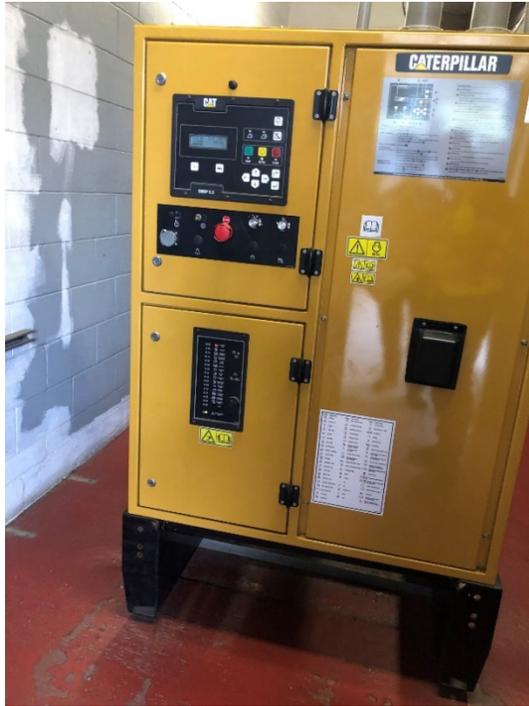
Photo 3.13 Backup Generator

- **Backup Generator:** The backup generator was evaluated to be in overall good condition. The generator was installed in 2010 and is used as temporary or emergency power. The generator can provide power needed to operate the plant during power outages. The generator itself was found to be in good condition; however, it is aging and is the only form of redundancy for the WWTP during a power outage.

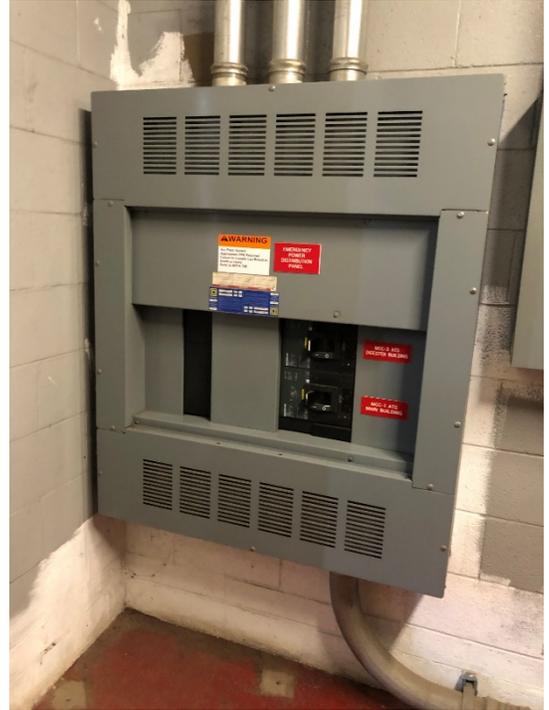
Photo 3.14 Emergency Distribution Panel

- **Emergency Distribution Panel:** The emergency distribution panel was evaluated to be overall good condition. The distribution panel is over 10 years old, but otherwise showing typical signs of use. Like the backup generator, this distribution panel is the only form of redundancy for the WWTP during a power outage.

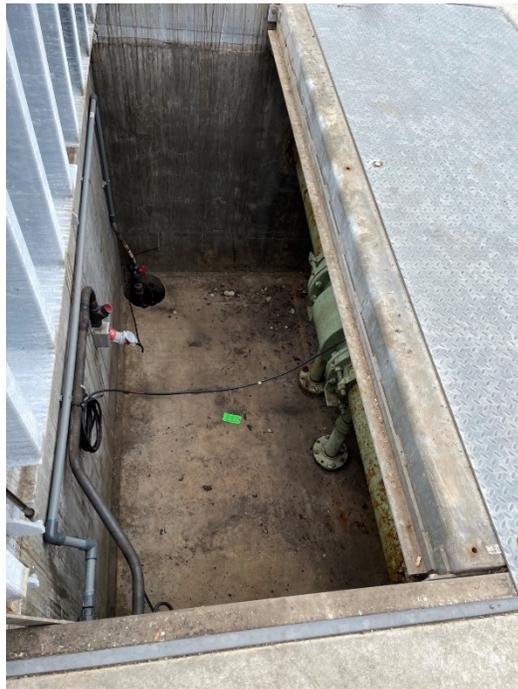
Photo 3.15 Influent Meter Vault

- **Influent Meter Vault:** The influent meter vault was evaluated to be in overall moderate condition. Some corrosion was observed on the piping exterior (surface corrosion) with flaking metal. The sump pump condition was not observed but was installed in 2005.

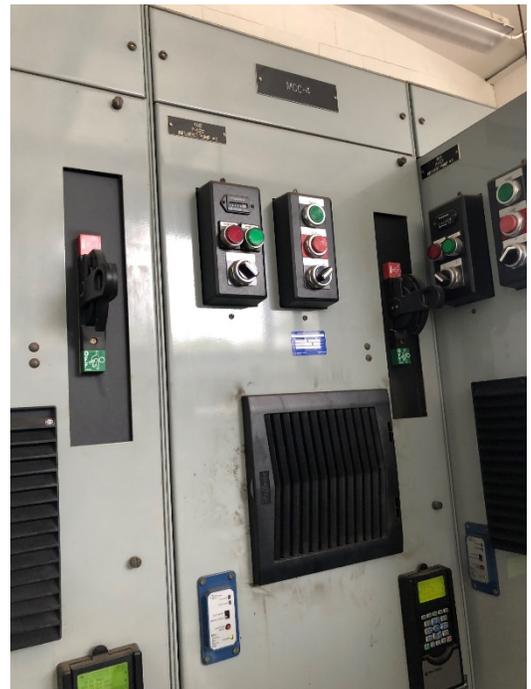
Photo 3.16 MCC No. 4

- **MCC No. 4:** MCC No. 4 was evaluated to be in overall good condition. While over 10 years old, wear is typical for this asset.

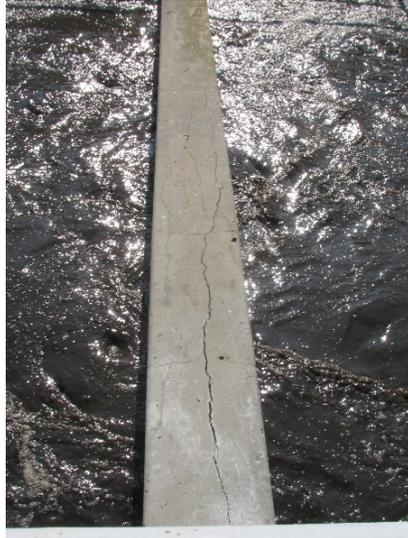
- **Aeration Basin 1:** Aeration Basin 1 was evaluated to be in overall moderate-to-poor condition. At the time of the condition assessment, the basin was in service so only the exterior was assessed. The west, east, and middle struts have heavy cracking on the north side and spalling is imminent (Photo 3.17). There is significant amount of cracking at the north side walkway with evidence of previous crack injection repairs and core sampling, presumably to investigate the cause of cracking (Photo 3.18). The extensive cracking observed at the top side of concrete members may be related to alkali-silica reaction (ASR), which is a long-term chemical reaction within the concrete that creates internal volumetric expansive stresses that can exceed the concrete tensile strength, resulting in cracking. Spalling was observed at the top of the east wall. Petrographic testing of the concrete can be performed to confirm this is the cause of the observed damage.

Photo 3.17 Aeration Basin 1 Strut Cracking

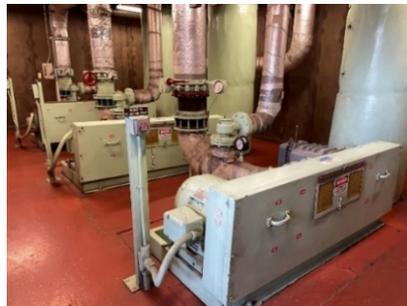
Photo 3.31 Aeration Basin Blowers

- Aeration Blowers and Motors 1 through 3: Aeration Blowers and Motors 1 through 3 were evaluated to be in moderate condition. Given the age and foul air service, the blowers are in remarkable condition and have been well maintained. They appear to have useful life remaining. Insulation on discharge piping is sufficient to protect staff, and noise levels are bearable. The inlet ducting is likely very corroded and contributing to accelerated wear of the blowers, air distribution system, and diffusers. It is also recommended that the blower inlet is moved from the influent wet well to an alternate location where the H₂S levels are not as high. This would trigger other improvements to handle the foul air in the influent wet well. It was also noted that Blower 3 leaks oil. All aeration blowers have been budgeted and scheduled to be replaced in 2022 as part of the Electrical Rehabilitation Project.

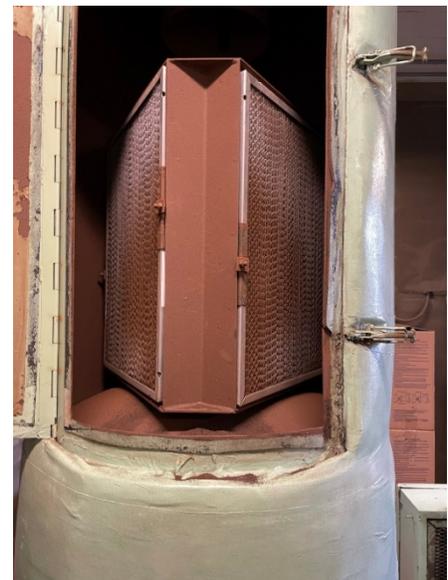
Photo 3.32 Aeration Basin Filter Silencer

Air intake comes from the influent wet well as a means of odor control. Foul air high in H₂S has caused a lot of corrosion of the inlet filter silencers and likely in the air distribution piping. An uninstalled standby blower is stored in the blower room. MSD is planning to replace the motors with units suitable for use with VFDs as part of the upcoming electrical project. They are also planning to incorporate dissolved oxygen (DO) control.

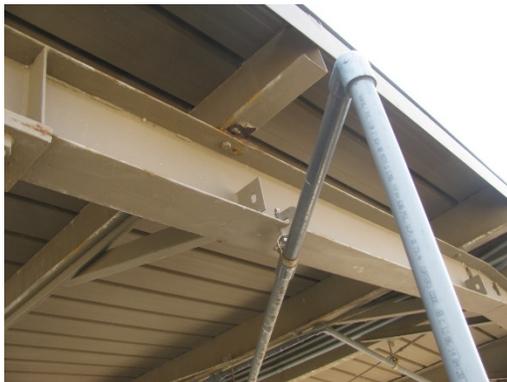
Photo 3.37 Chemical Storage Area Canopy

- Chemical Storage Canopy (west of Aeration Basin 2): The chemical storage canopy was evaluated to be in moderate condition. This single canopy metal building has a few local areas of severe corrosion. The coating is mostly intact, but severe corrosion was observed at the connections.

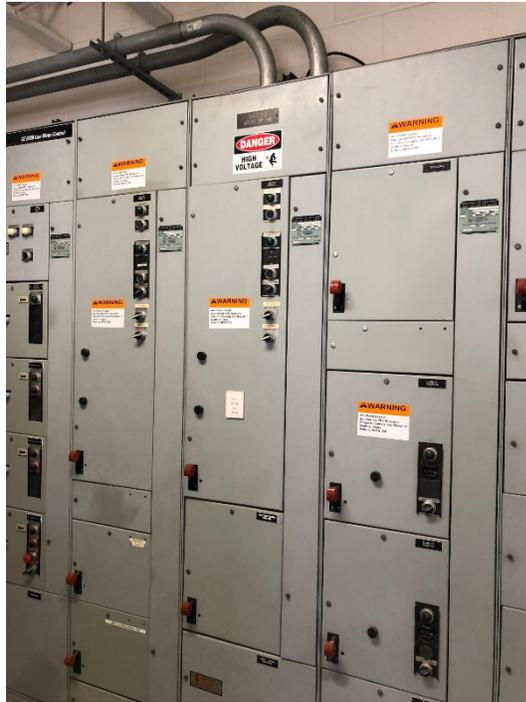
Photo 3.45 MCC No. 3

- MCC No. 3: MCC No. 3 was evaluated to be in very poor condition. It is more than 30 years old, and while still functioning, the equipment is obsolete.
- Annunciator Panel: The annunciator panel was evaluated to be in very poor condition. It is more than 20 years old, deteriorating, and in very poor condition. It is also obsolete.
