Montecito Sanitary District & Montecito Water
District
Enhanced Recycled Water Feasibility Analysis

Technical Memorandum 3 CONDITION ASSESSMENT

FINAL | April 2022

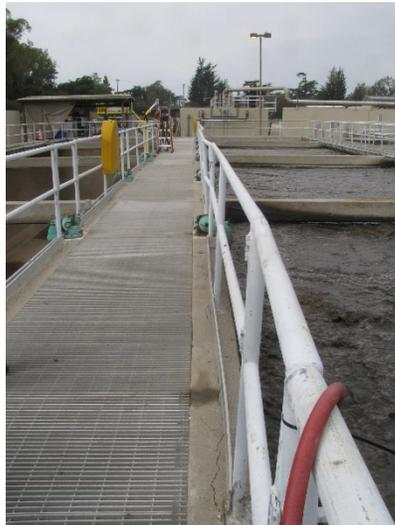
- Exterior Assessment: The assessment found typical concrete cracking on the top concrete walking surfaces at the guardrail post embeds (Photo 3.19). The guardrail is a z-rail with coating that has local fractures throughout. The concrete beams that span over the top of the basin generally have numerous longitudinal concrete cracks with heavier cracking observed at the middle and east beams. The west cross beam has a patch of exposed rebar but no spalled concrete (Photo 3.21). It also has large cracks similar to the middle beam (Photo 3.20). There was pervasive cracking at the south top slab with evidence of prior repairs. The south top slab appears to have structural flexure cracks at the cantilever, but these cracks might also be due to ASR. The southeast corner top slab has exposed rebar with spalled concrete. Concrete cracking was observed at the outlet windows/channels, which could be a result of rebar corrosion. The west weir plate is severely corroded and in poor condition (Photo 3.23).

Photo 3.19 Aeration Basin Cracking at Guard Post

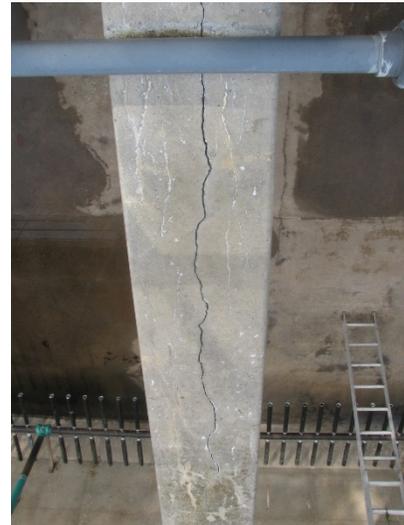
Photo 3.20 Aeration Basin 2 Cross Beam Longitudinal Cracking

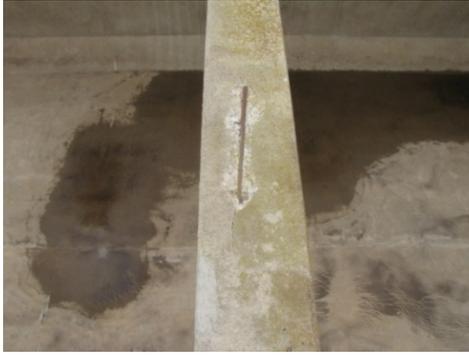
Photo 3.21 Aeration Basin 2 Exposed Rebar

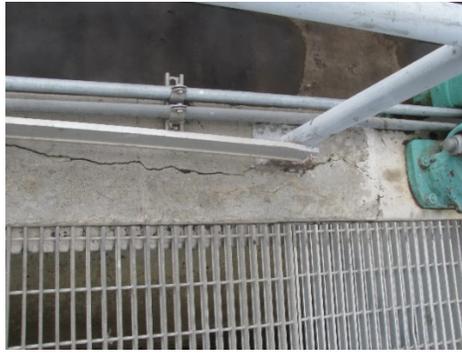
Photo 3.22 Aeration Basin 2 Evidence of Repairs

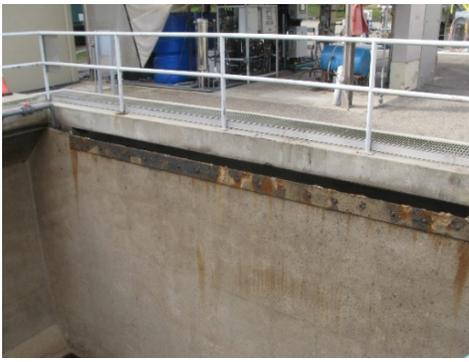
Photo 3.23 Aeration Basin 2 Wier Plate

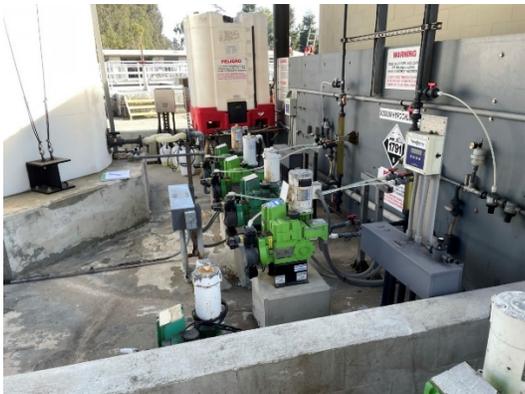
Photo 3.35 Sodium Hypochlorite Storage Facility

- Sodium Hypochlorite Storage Facility: The sodium hypochlorite storage facility was evaluated to be in poor condition. Although well maintained, there is a lot of corrosion. The diaphragm metering pumps work well and are easy to replace at the end of their useful life. The floor coating has failed. The coating is beginning to peel off the metal canopy. Moderate to minor steel surface corrosion was observed as shown in (Photo 3.38). There is no longitudinal bracing, and the canopy has insufficient separation from the adjacent canopy. This condition can allow structural pounding to occur during an earthquake, which can damage the supporting columns and framing.

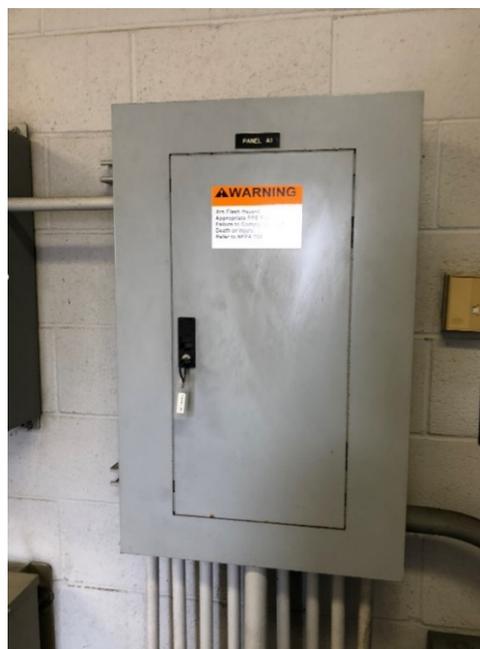
Photo 3.44 Blower Room Distribution Panels

- **RAS Dry Well Sump Pump:** The RAS dry well sump pump was not evaluated. The sump pump and control is budgeted and scheduled for replacement in 2022.
- **MCC No. 2:** MCC No. 2 was evaluated to be in overall good condition. While more than 10 years old, it is in good condition with typical wear for its age.
- **MCC No. 2 Control Panel:** MCC No. 2 Panel was evaluated to be in overall good condition. It is more than 10 years old. It is showing typical aging but is in overall good condition.
- **Distribution Panels:** The distribution Panels by MCC2 were evaluated to be in very poor condition. This pertains to distribution panels A1, B1, the 45 kilovolt-ampere (kVA) transformer and 5-kVA transformer and disconnect. This electrical equipment is more than 20 years old and is deteriorated and obsolete. The blower distribution panels have been budgeted and scheduled for replacement in 2022.

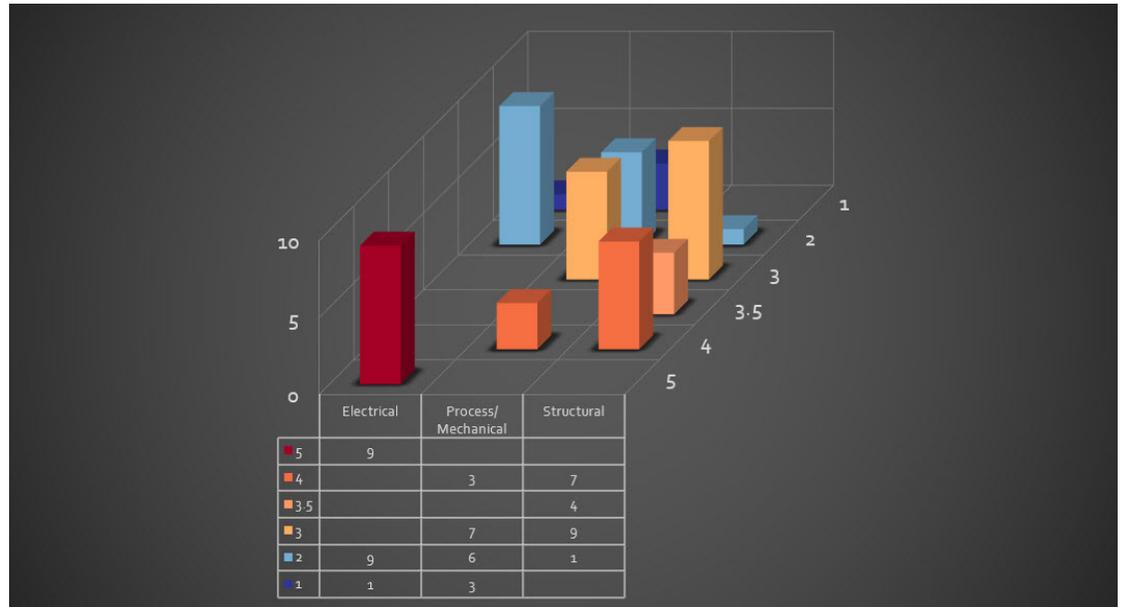
Figure 3.3 Condition Assessment Scores by Discipline

This TM presents the condition assessment results for the MSD WWTP. The results are summarized by discipline in Figure 3.3. Overall, electrical assets were the only assets that scored in very poor condition, and most of these assets are scheduled for replacement in 2022. Structural assets had the most assets scoring in the moderate to poor range.

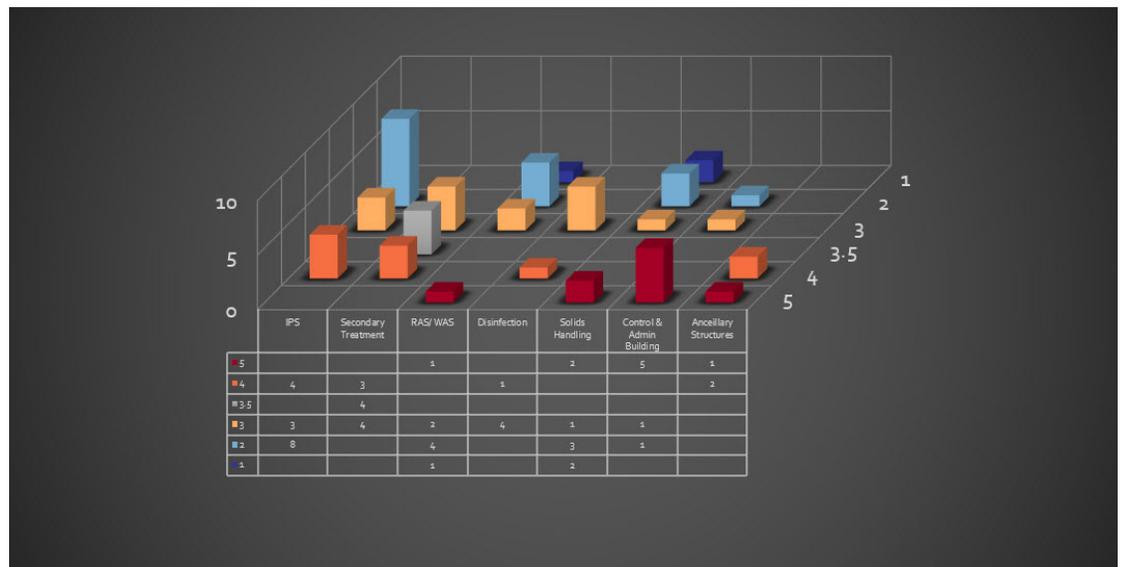
Figure 3.4 Condition Assessment Scores by Process Area

Scores by process area show are illustrated in Figure 3.4 below. It shows that assets in the poor to very poor are throughout the WWTP and can affect nearly all process areas.
